New Hampshire Volunteer Lake Assessment Program

2002 Interim Report for Spofford Lake Chesterfield

NHDES
Water Division
Watershed Management Bureau
6 Hazen Drive
Concord, NH 03301

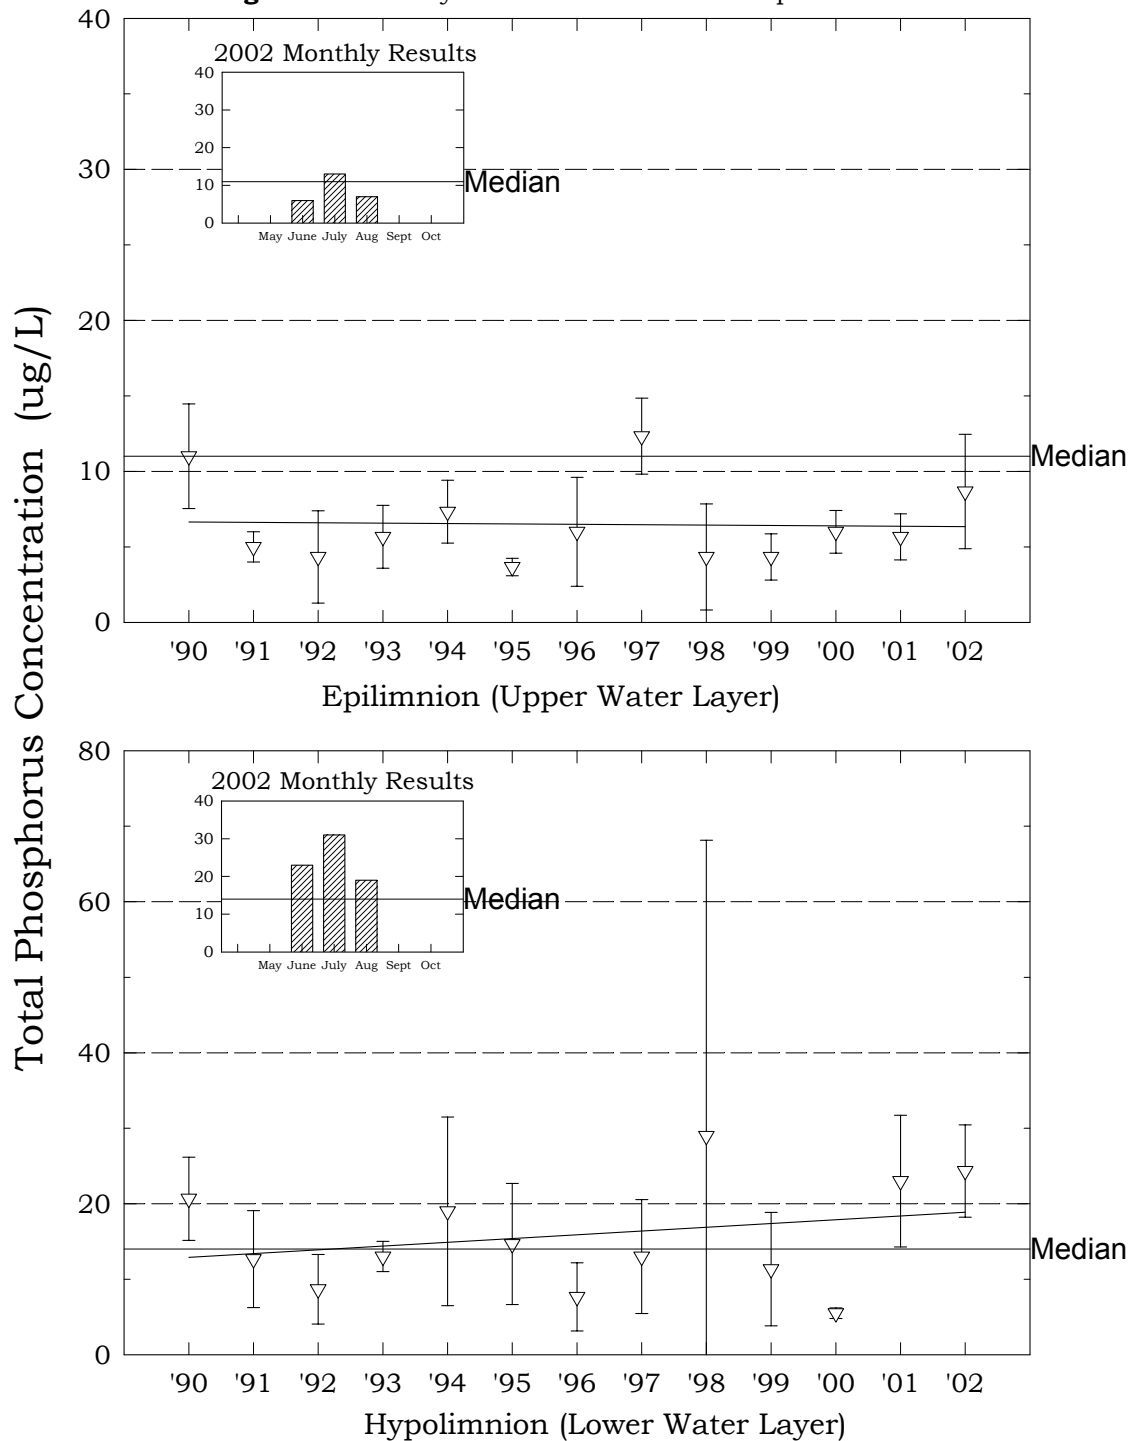
Figure 3. Monthly and Historical Total Phosphorus Data.

- **Figure 3 and Table 8:** The graphs in Figure 3 (Appendix A) show the amounts of phosphorus in the epilimnion (the upper layer) and the hypolimnion (the lower layer); the inset graphs show current year data. Table 8 (Appendix B) lists the annual maximum, minimum, and median concentration for each deep spot layer and each tributary since the lake/pond has joined the program.

The historical data for the epilimnion (upper layer) show that the 2002 total phosphorus mean is ***slightly less than*** state median.

The historical data for the hypolimnion (lower layer) show that the 2002 total phosphorus mean is ***greater than*** the state median.

Overall, visual inspection of the historical data trend line for the epilimnion and the hypolimnion shows ***a variable*** total phosphorus trend, which means that the concentration has ***fluctuated*** since monitoring began.

One of the most important approaches to reducing phosphorus loading to a waterbody is to continually educate watershed residents about its sources and how excessive amounts can adversely impact the ecology and value of lakes and ponds. Phosphorus sources within a lake or pond's watershed typically include septic systems, animal waste, lawn fertilizer, road and construction erosion, and natural wetlands. If you would like to educate watershed residents about how they can help to reduce phosphorus loading into the lake/pond, please contact the VLAP Coordinator.
